# Esthetic Restoration of Complicated Crown-Root Fractures Utilizing Orthodontic Extrusion

*Department of Pediatric Dentistry, Sun Dental Hospital*

This case report describes the clinical procedures involved in the treatment of trauma-induced complicated crown-root fractures in the maxillary incisor of two young patients. Conventional root canal treatment and apexification were performed in each patient. To expose the fracture margins to the supragingival level and to reestablish the biologic width, orthodontic extrusions with fixed appliances were performed followed by a retention period. During the retention period, fiber-optic posts and cores were built up and provisional crowns were placed. Finally, ceramic crowns manufactured using a computer-aided design/computer-aided manufacturing (CAD/CAM) system were placed.

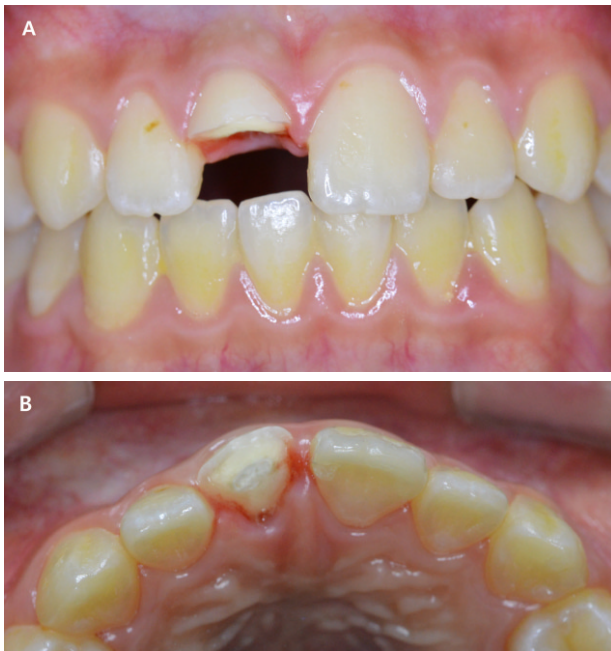
A 12-year-old male reported an accident during school activity 2 hours before, which resulted in fracture of maxillary right central incisor. The patient had no specific medical history. Clinical examination revealed an oblique crown-root fracture of maxillary right central incisor with the fracture line extending subgingivally at the palatal aspect (Fig. 1). The fractured coronal seg-

**Fig. 1.** Intraoral views showing fractured maxillary right central incisor. (A) Facial view. (B) Occlusal view.

On the basis of clinical and radiographic findings, a diagnosis of complicated crown-root fracture was made. A definitive treatment plan was developed to include a root canal treatment and post-retained crown along with orthodontic extrusion to move the fracture line 3 mm above the alveolar crest. This would restore the lost biologic width and allow sufficient tooth area available for core build-up and crown preparation.

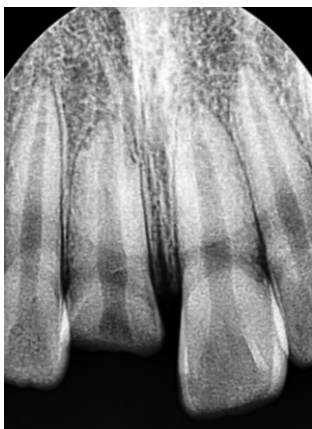
**Fig. 2.** Preoperative periapical view showing the extent of fracture and closure of the root apex.

ment was already detached and the pulp was exposed. The tooth had no mobility and no sensitivity to percussion. Radiographic examination confirmed the findings of the clinical examination; the fracture line on the palatal side could be traced about 1 mm below the alveolar crest and the root apex was closed (Fig. 2). There was no damage to adjacent teeth or other facial bones (Fig. 3).

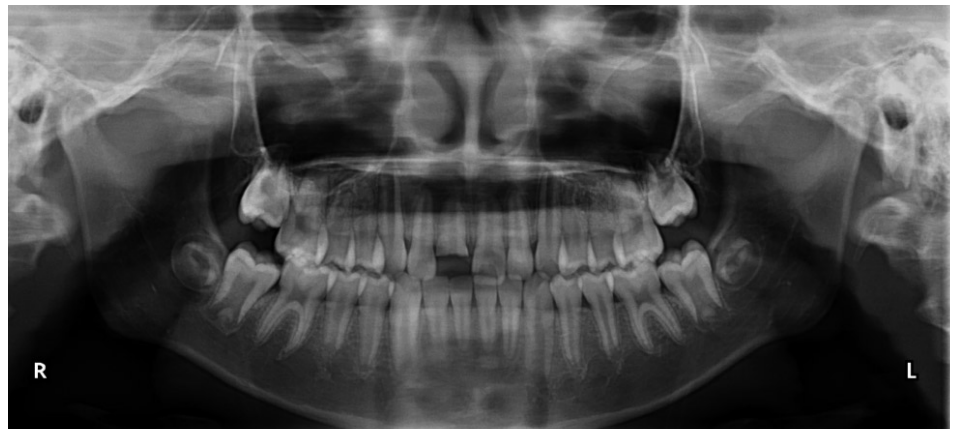
**Fig. 3.** Preoperative panoramic view. No damage was found in the adjacent teeth and other facial bones.

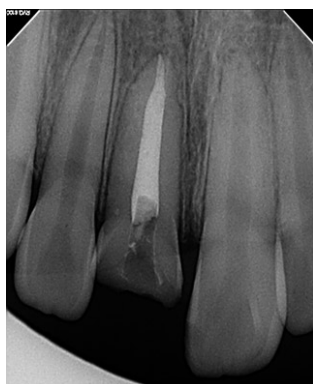
**Fig. 4.** Periapical view after conventional root canal treatment.

In the first stage of treatment, a conventional root canal treatment was performed (Fig. 4). Brackets were bonded to the adjacent teeth, a temporary intracanal post was placed and extrusive force was provided to the post by an elastic thread (Fig. 5). To achieve tooth extrusion without alteration of gingiva level, rapid extrusion was planned. The aimed extrusion force was approximately 80 - 100 mg and the force was measured by a force gauge. After 2 weeks, 1 mm of extrusion was achieved. However, several problems such as elastic thread snap, discomfort of tooth, and difficulty in controlling the direction and amount of force occurred. Therefore the design of extrusion was changed.

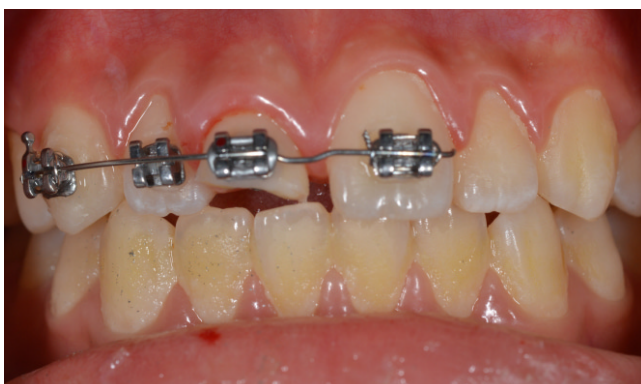
**Fig. 6.** Intraoral view of the orthodontic extrusion with brackets, around 4 mm of extrusion had been achieved within 6 weeks and the coronal migration of soft tissue was notable.

Fortunately, there was sufficient space on the labial surface of the fractured tooth to place a bracket. This new bracket was placed more gingivally on the tooth to be extruded and the extrusion force was provided by an orthodontic wire. After 6 weeks of treatment, around 4 mm of extrusion had been achieved totally (Fig. 6). The horizontal wire and brackets were removed after 8 weeks because bony and periodontal repair were evident (Fig. 7).

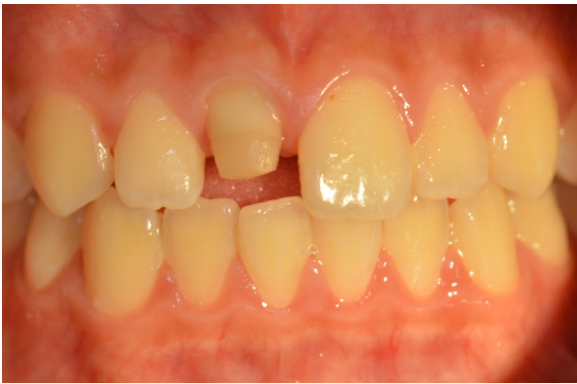
**Fig. 8.** Intraoral view after post and core build up.

After then, the patient was referred to the prosthodontist. Before tooth preparation, gingivectomy was performed to correct the discrepancy of the gingival margin due to coronal migration of the soft tissue. Subsequently, a fiber-optic post (ParaPost® Taper Lux, Coltene) was cemented and a core (LuxaCore® Dual, DMG) was built up (Fig. 8). Afterwards, the tooth preparation was done and a provisional crown was placed (Fig. 9). Treatment

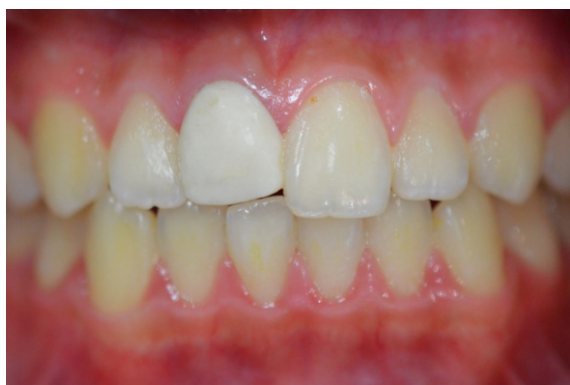
**Fig. 9.** Intraoral view after provisional crown placement.

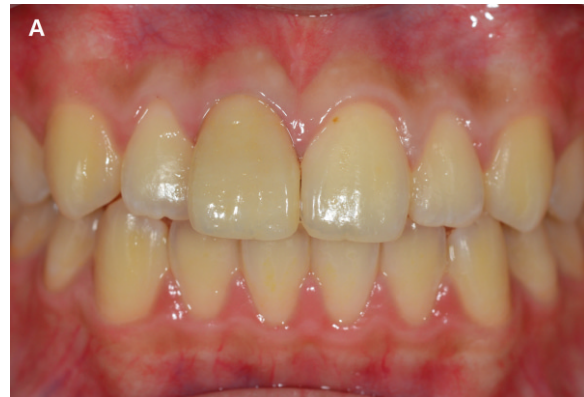
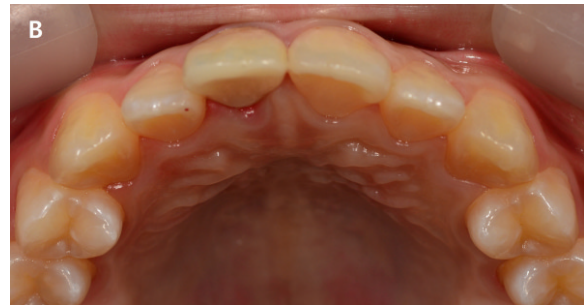
**Fig. 10.** Intraoral view after final restoration, good esthetics were achieved. (A) Facial view. (B) Occlusal view.

was temporarily ceased by the patient for personal reasons. After 6 months, the patient returned to continue the remaining treatment. The provisional crown was removed and the condition of both the tooth and gingiva was found to be in good condition. A final impression was taken using an oral scanner (CEREC® Omnicam, Sirona) and an all-ceramic crown (IPS e.max® CAD, Ivoclar Vivadent) was made by computer-aided design/computer-aided manufacturing (CAD/CAM) milling machine (CEREC® MC XL, Sirona). The crown was placed and good esthetics were achieved (Fig. 10).

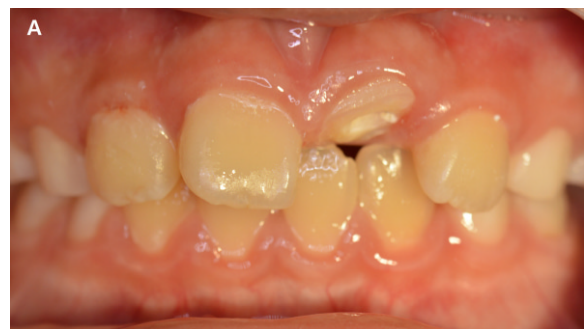
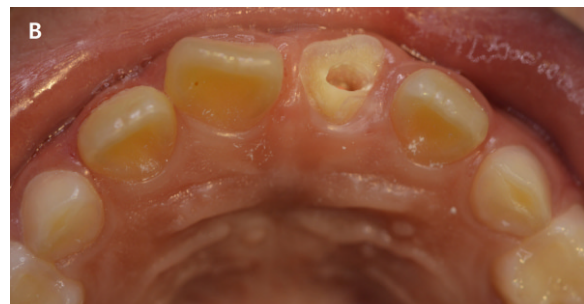
A 9-year-old male reported with a chief complaint of anterior tooth fracture and a history of falling down and bumping into a corner of his bed the night before. The patient had no specific medical history. The clinical examination revealed an oblique crown-root fracture of maxillary left central incisor with the fracture line extending subgingivally at the disto-palatal aspect (Fig. 11). The coronal fragment was lost. The tooth had no mobility but presented tenderness to percussion. In addition, both lower central incisors showed slight enamel fracture on the incisal tip. Through radiographic examination, uncompleted root formation and an open apex was found; the fracture line on the palatal side was above the alveolar crest (Fig. 12). There was no damage to other facial bones (Fig. 13).

**Fig. 11.** Intraoral views showing fractured maxillary left central incisor. (A) Facial view. (B) Occlusal view.

On the basis of clinical and radiographic findings, a diagnosis of complicated crown-root fracture with concussion of maxillary left central incisor and enamel fracture of lower central incisors was made. For treatment, apexification with mineral trioxide aggregate (MTA) and a post-retained crown were planned. This would be followed by orthodontic extrusion to move the fracture line above the gingival margin to regain the lost biologic width and improve the retention of the prosthetic crown.

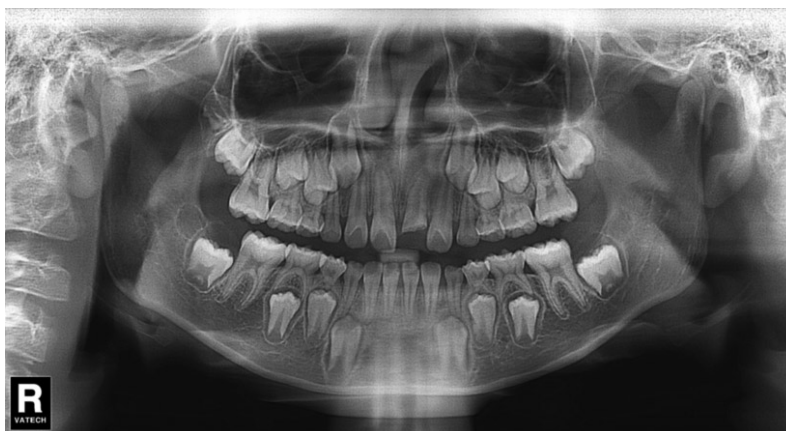
**Fig. 13.** Preoperative panoramic view. Minor enamel fractures were found in the mandibular central incisors but no damage was found in the surrounding bone.

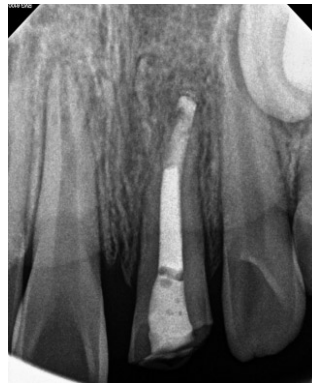
**Fig. 17.** Periapical view after 8 weeks of stabilization, showing good bony repair.

After 4 weeks retention, the bony and periodontal repair was evident and the horizontal wire and button were removed (Fig. 17, 18). After then, the patient was referred to the prosthodontist. A fiber-optic post (ParaPost® Taper Lux, Coltene) was cemented and a core (LuxaCore® Dual, DMG) was built up. After the tooth preparation and a final impression with the oral scanner (CEREC® Omnicam, Sirona), a provisional crown was placed and the tooth was stabilized for an additional 4 weeks. Finally, a porcelain veneered zirconia (PFZ) crown (zirconia coping: ZirPremium® UT, Acucera, porcelain veneer: Vitablocs® MarkII, Vita Zahnfabrik) which was made by CAD/CAM milling machine (CEREC® MC XL, Sirona) was placed (Fig. 19).

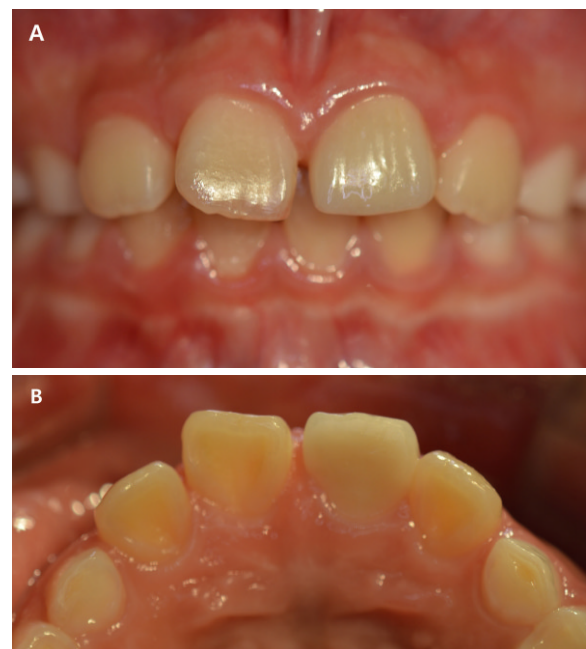
**Fig. 19.** Intraoral view after final restoration, good esthetics were achieved. (A) Facial view. (B) Occlusal view.

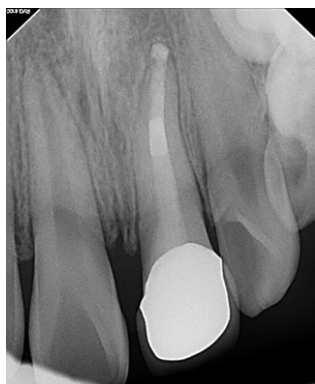
**Fig. 20.** Follow-up radiograph showing a hard tissue barrier in the root apex.

The patient was kept on recall checks to monitor the restoration. Through periapical radiographs, formation of a hard tissue apical barrier was found (Fig. 20). The tooth showed good esthetic results and no relapse was noted. In addition, the periodontal tissues were healthy.
