## Orthodontic Traction of Impacted Teeth with Modified Nance Appliance: Case Reports

Department of Pediatric Dentistry, School of Dentistry, Chonnam National University

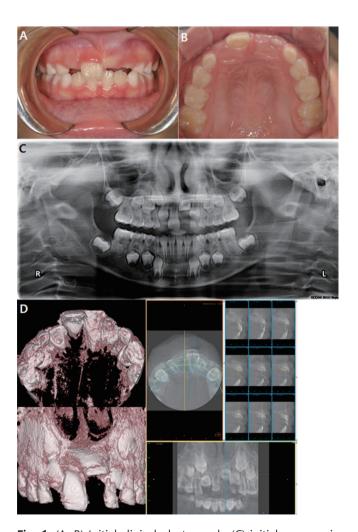
**Fig. 1.** (A, B) Initial clinical photograph, (C) initial panoramic radiograph and (D) initial CBCT images of patient 1.

A 7-year-old girl was referred from a local clinic with chief complaint of a missing maxillary anterior tooth. The patient had no significant medical history. On intraoral examination, the maxillary left central incisor was detected on buccal mucosa above mucogingival junction(Fig. 1A, 1B). She presented Class I molar relationship bilaterally with normal overjet and overbite. On the panoramic radiograph(Fig. 1C) and CBCT images(Fig. 1D), horizontally impacted maxillary left central incisor was observed.

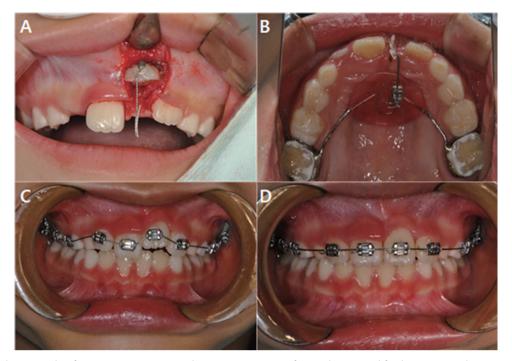
**Fig. 2.** Clinical photograph of patient 1. (A) Surgical exposure was performed. (B) Modified Nance appliance was delivered. (C, D) Fixed orthodontic appliances were bonded on the maxillary arch for leveling and finishing.

Closed eruption technique was performed. The crown of #21 was exposed and a button with ligature wire chain was bonded on the labial surface of the tooth(Fig. 2A). The flap was sutured back. A week later, the suture was removed and pick-up impression for an orthodontic appliance was taken with alginate. A modified Nance appliance with bracket on its resin button was delivered in a week. A traction wire was fabricated with TMA wire and ligated to a bracket on the appliance(Fig. 2B). The ligature chain was placed on the terminal hook of traction wire for application of traction forces. Approximately 60 gm of force was applied. The patient was checked at monthly intervals to monitor the traction force and adjust the appliance. After 3 months, #21 emerged into the oral cavity.

The modified Nance appliance was removed and fixed orthodontic appliances were bonded on the maxillary arch for further alignment(Fig. 2C). Typical leveling and finishing procedures were continued(Fig. 2D). After 8 months, the brackets and bands were removed.

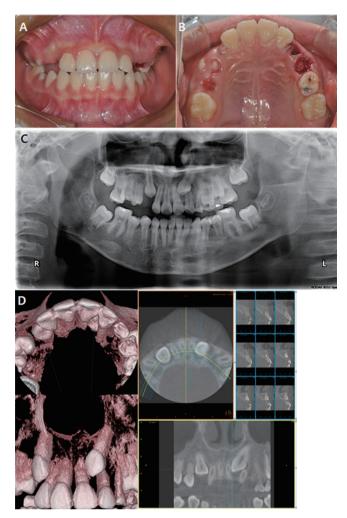
**Fig. 5.** (A, B) Initial clinical photograph, (C) initial panoramic radiograph and (D) initial CBCT images of patient 2.

A 9-year-old girl was referred from a local clinic with chief complaint of an impacted permanent maxillary left canine. The patient had no significant medical history. An intraoral examination revealed retained deciduous maxillary left canine and a Class I molar relationship on both sides(Fig. 5A, 5B). A panoramic radiograph showed impaction of the permanent maxillary left canine which was superimposed with the root of the left lateral incisor(Fig. 5C). CBCT images revealed mesiobuccally impacted maxillary left canine and the crown of the tooth located between #21 and #22(Fig. 5D).

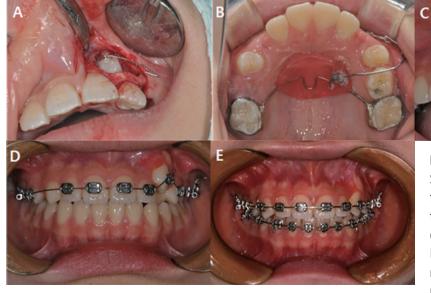
**Fig. 6.** Clinical photograph of patient 2. (A) Surgical exposure was performed. (B) Modified Nance appliance was delivered. A traction force was applied to the distobuccal direction. (C) Apically positioned flap was performed. (D) Fixed orthodontic appliances were bonded on maxillary arch. (E) Second phase orthodontic procedures using fixed orthodontic appliance were performed.

Surgical exposure and button attachment were performed with the same procedures as described above for Case 1(Fig. 6A). After 7 days, the suture was removed and pick-up impression was taken to fabricate an appliance.

A modified Nance appliance was delivered in a week. A traction wire to move the tooth to the distobuccal direction was made with TMA wire and ligated to the bracket on the appliance(Fig. 6B). Approximately 100 gm of force was applied to the tooth. The patient was admitted at monthly intervals to check the traction force and adjust the appliance. For the first 5 months of traction using modified Nance appliance, the tooth moved to distobuccal side.

An apically positioned flap was then performed so as to provide enough attached gingiva to the tooth(Fig. 6C). The modified Nance appliance was removed and fixed orthodontic

appliances were bonded to the upper arch(Fig. 6D). Flexible NiTi wire was engaged to the upper arch. When #23 reached to occlusal level, fixed appliances were bonded and NiTi wire was engaged to the lower arch. As the treatment progressed, the NiTi wire was replaced with rectangular stainless steel wire(Fig. 6E). After 20 months, the brackets and bands were removed.

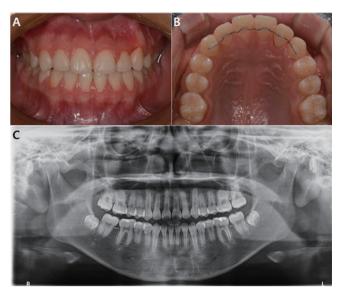
**Fig. 7.** (A, B) Clinical photograph and (C) panoramic radiograph of patient 2 after debonding.

After 5 months of traction using modified Nance appliance followed by 20 months of second phase orthodontic procedures, treatment was completed. The left maxillary canine was positioned adequately in the dental arch with enough width of attached gingiva(Fig. 7). Fixed and removable retainers for upper and lower arch were delivered to the patient.

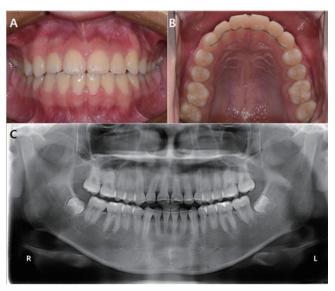
**Fig. 8.** (A, B) Clinical photograph and (C) panoramic radiograph of patient 2 after 8 months follow-up.

Over 8 months of clinical and radiographic follow up, its bone level and attachment level were similar to those of the adjacent teeth(Fig. 8).

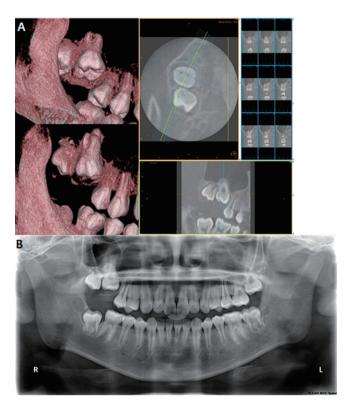
**Fig. 9.** (A) Initial CBCT images and (B) initial panoramic radiograph of patient 3.

An 11-year-old boy was referred from a local clinic with chief complaint of an unerupted molar. The patient had no significant medical history. On the panoramic radiograph and CBCT images, the maxillary right first molar had not erupted(Fig. 9A, 9B).

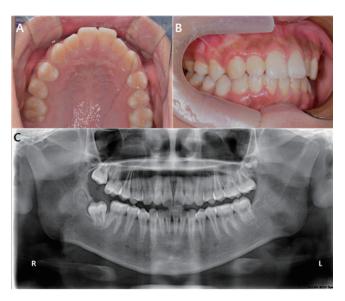
**Fig. 11.** (A, B) Clinical photograph and (C) panoramic radiograph of patient 3 after debonding.

After 2 months of debonding, the tooth completely erupted without periodontal problems(Fig. 11). Over 28 months of clinical and radiographic follow up, no abnormal findings such as root resorption were observed(Fig. 12).

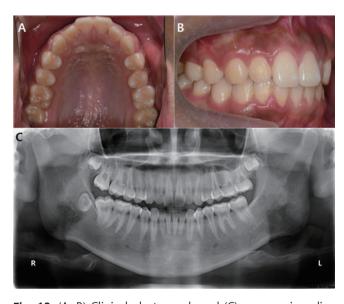
**Fig. 12.** (A, B) Clinical photograph and (C) panoramic radiograph of patient 3 after 2 years 4 months follow-up.
